# Red Hook Water Storage Tank Engineering Report

Town of Red Hook Water District No. 1

August 24, 2022

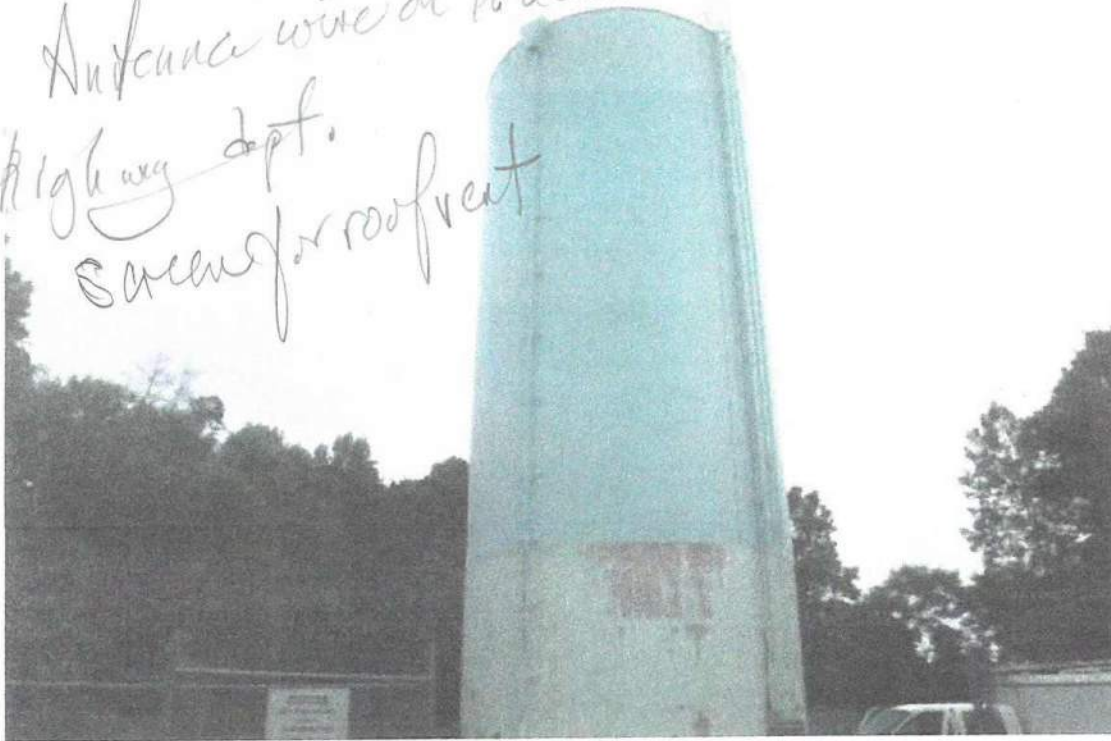
*Note: Antenna wire on ladder  
= Highway Dept.  
Screen for roof vent*

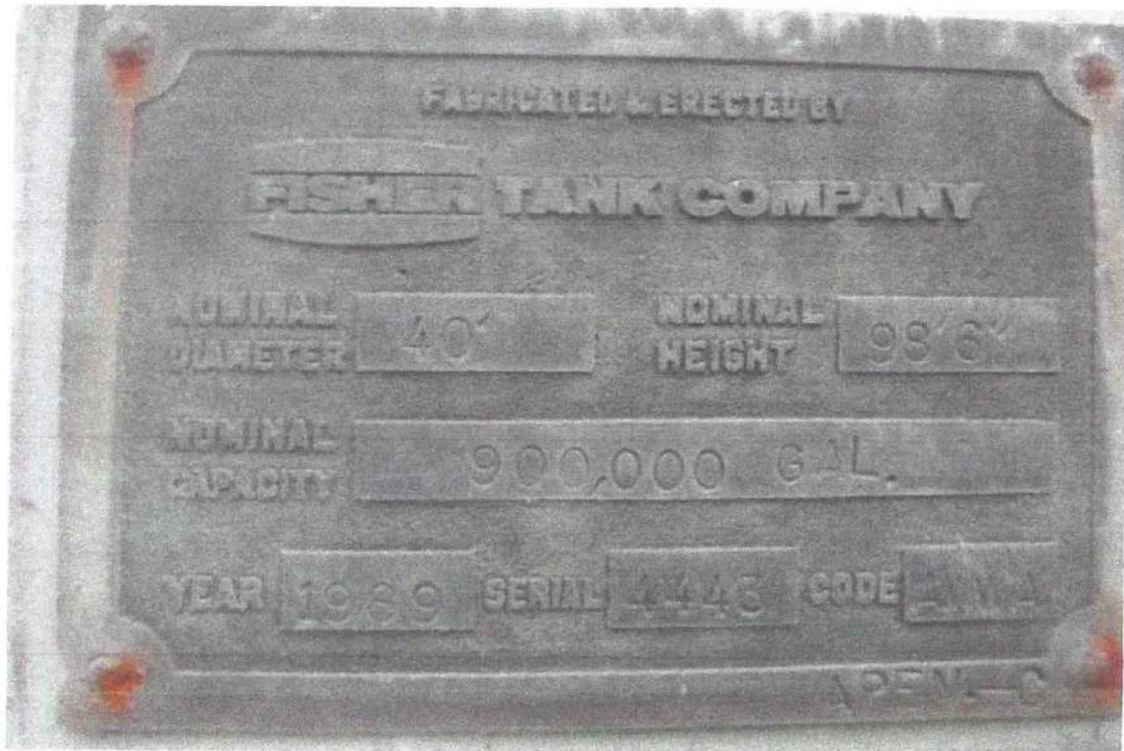
Photo shows the tank name plate.

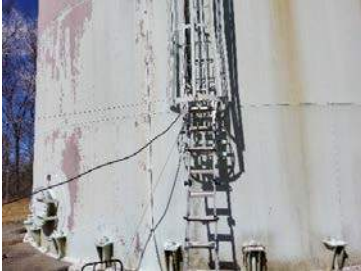
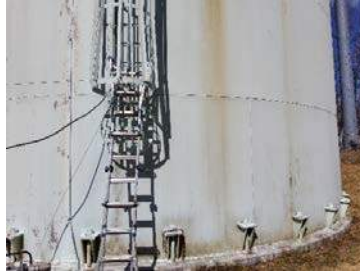
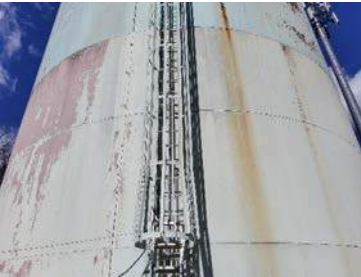
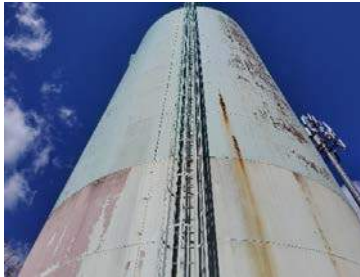
#### North Wall Exterior Aesthetics Photos

Aesthetics	Mildew
Condition of Protective Coating	Decline/Thinning

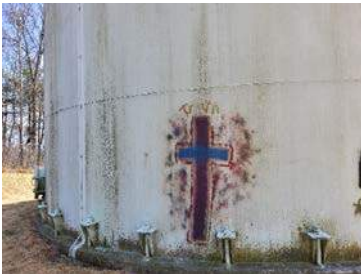
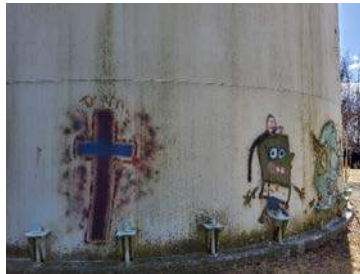
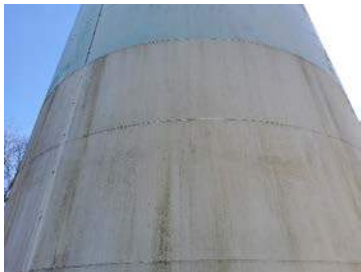
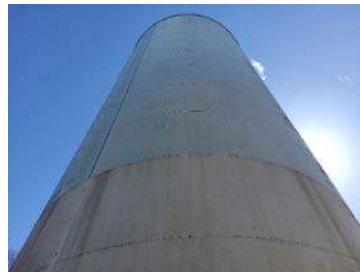
#### South Wall Exterior Aesthetics Photos

Aesthetics	Graffiti/Mildew
Condition of Protective Coating	Decline/Thinning/Peeling

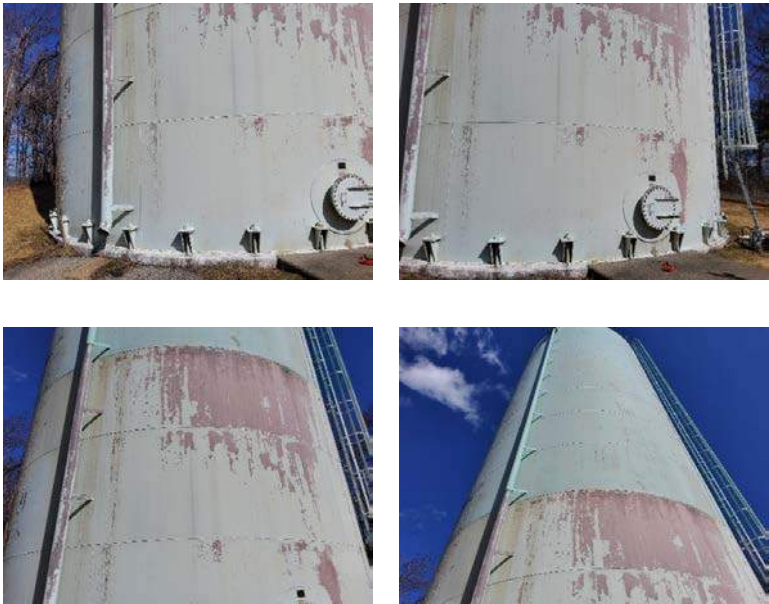
East Wall Exterior Aesthetics Photos

EAST WALL	
Aesthetics	Mildew
Condition of Protective Coating	Decline/Thinning

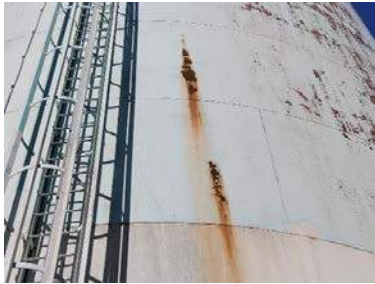
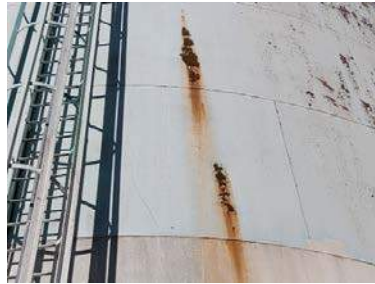
<b>MIDDLE SECTION NORTH WALL</b>	
Is there any sign of exposed steel in this section?	Yes
Percent (%) of exposed steel in this section	Less than 5%
Is there any sign of corrosion in this section?	No
Is there any sign of pitting in this section?	No

Exterior Middle North Wall Section - Photo of exposed steel

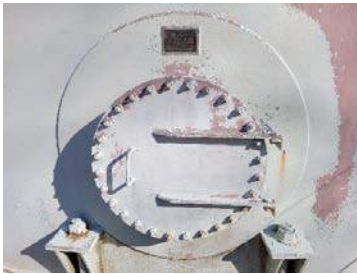
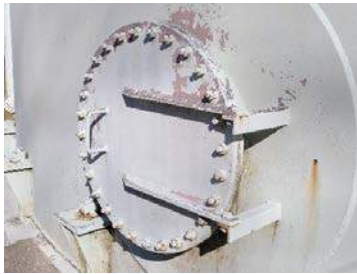
#### Exterior Manway 1 Photos

EXTERIOR MANWAY #1	
Location #1	Southwest
Location #2	Wall
Shape	Circle
Diameter (in inches)	32
Height above the ground (in inches)	22
Is this manway secure?	Yes
Is there any sign of leakage?	No
Is this manway coated?	Yes
Condition of coating	Peeling
Is there any signs of metal exposure?	No
Is there any sign of corrosion?	No
Is there any sign of fatigue/pitting?	No
Dry Film Thickness Measurements (In Mils)	12.2 10.7 5.4 8.9
Ultra Sonic Thickness Measurements (In Inches)	1.069,1.075 , 1.075 , 1.066
What is the condition of the gasket?	Good

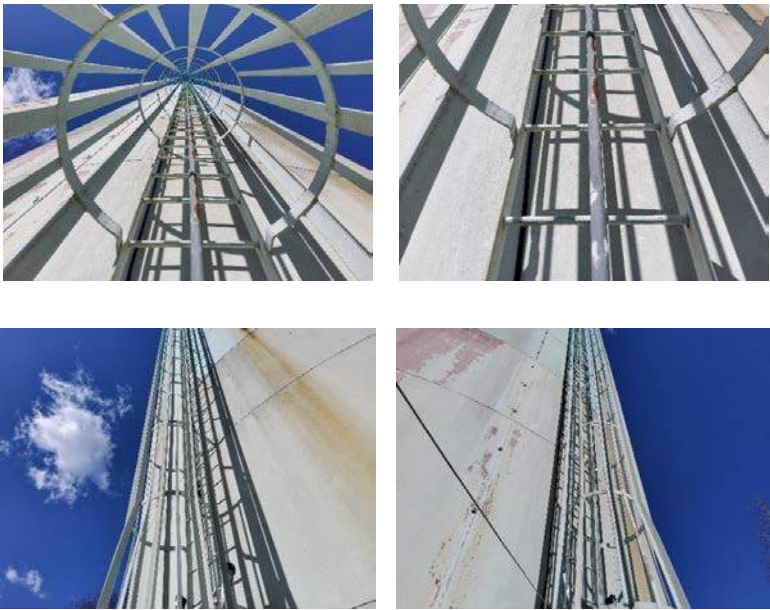
Exterior Ladder Photos

EXTERIOR LADDER SECURITY AND FALL PREVENTION	
Does this ladder have a fall prevention device?	Yes
What type of fall prevention device is available?	Notched Tube
What is the condition of this fall prevention device?	Good
Does this ladder have a safety cage?	Yes
What is the condition of the safety cage?	Good
Does this ladder have a ladder guard?	Yes
Is this ladder guard locked?	No

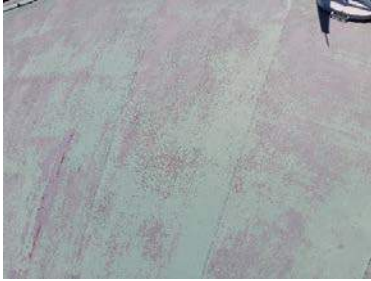
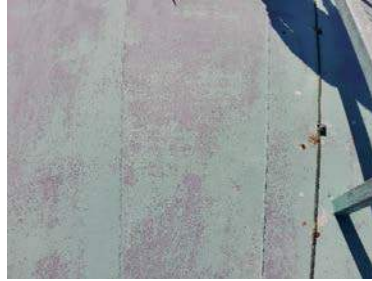
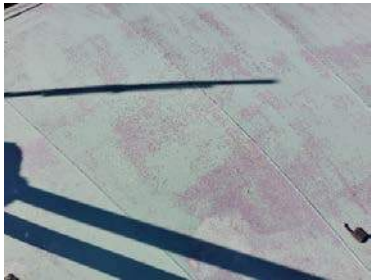
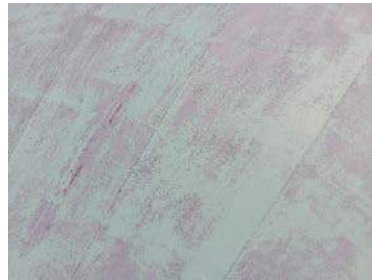
North Roof Quadrant Aesthetic Photos

NORTH ROOF QUADRANT AESTHETICS	
Aesthetic Deficiencies	No Visible Deficiencies
Condition of Protective Coating	Decline/Thinning

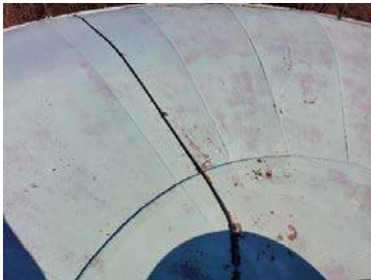
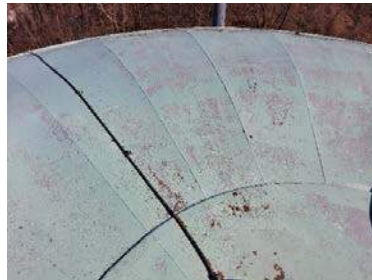
South Roof Quadrant Aesthetic Photos

SOUTH ROOF QUADRANT AESTHETICS	
Aesthetic Deficiencies	No Visible Deficiencies
Condition of Protective Coating	Decline/Thinning

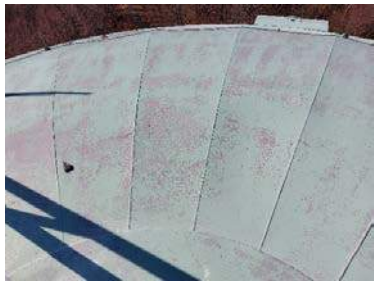
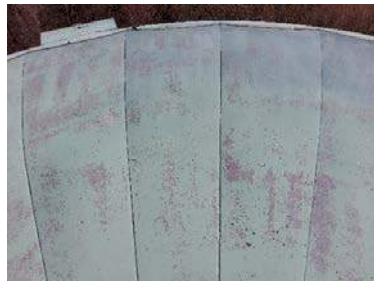
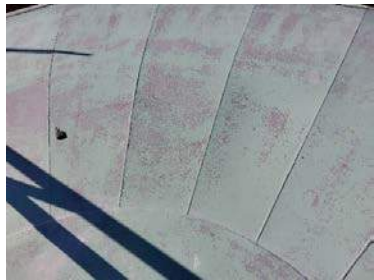
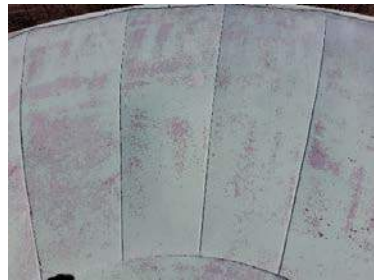
East Roof Quadrant Aesthetics Photos

EAST ROOF QUADRANT AESTHETICS	
Aesthetic Deficiencies	No Visible Deficiencies
Condition of Protective Coating	Decline/Thinning

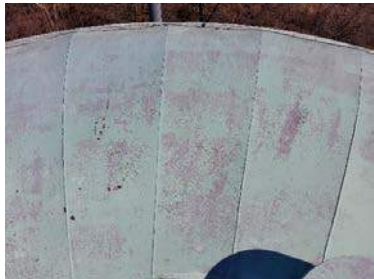
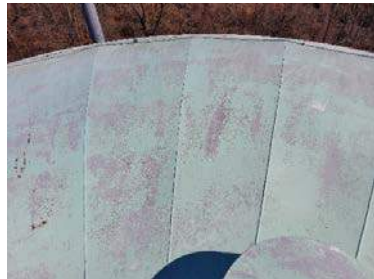
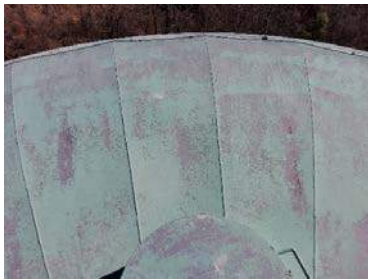
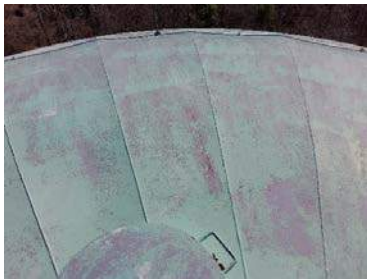
West Roof Quadrant Aesthetics Photos

WEST ROOF QUADRANT AESTHETICS	
Aesthetic Deficiencies	No Visible Deficiencies
Condition of Protective Coating	Decline/Thinning

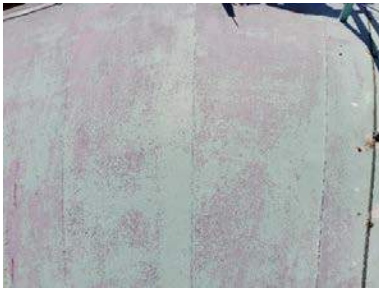
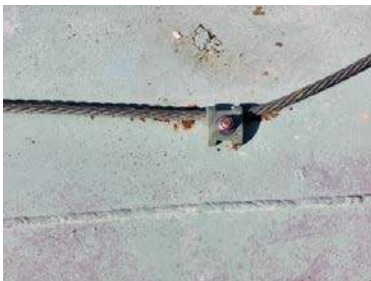
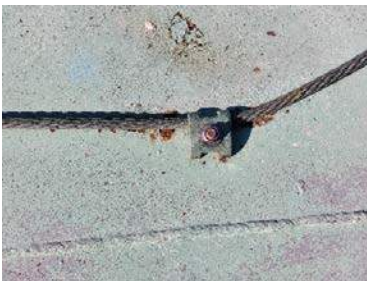
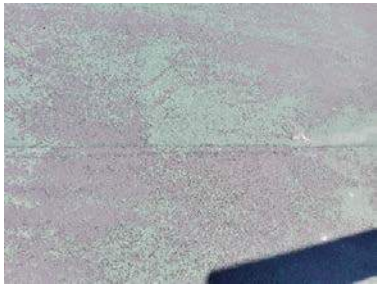
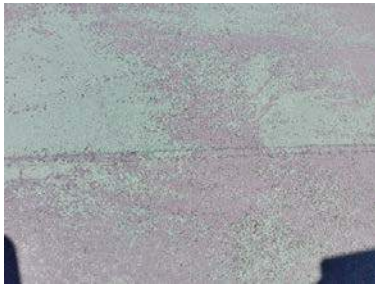
##### NORTH ROOF STRUCTURAL

Is there any sign of exposed steel?	Yes
Percent (%) of exposed steel in this quadrant	Less than 5%
Is there any sign of corrosion?	No
Is there any sign of pitting?	No
Are all penetrations sealed?	Yes
Ultra Sonic Thickness Measurements (In Inches)	.302 .311 .338 .325
Dry Film Thickness Measurements (In Mils)	6.4 6.8 5.28 7.2
Do all the welds in this section appear to be sound, free of fatigue /failure?	Yes
Does there appear to be any sign of leakage?	No

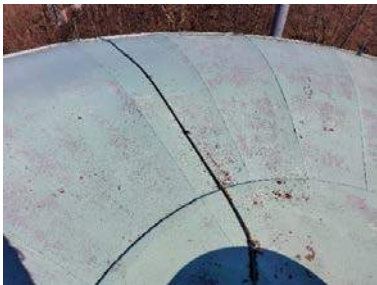
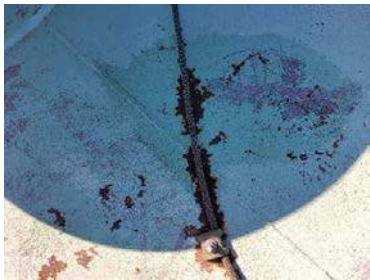
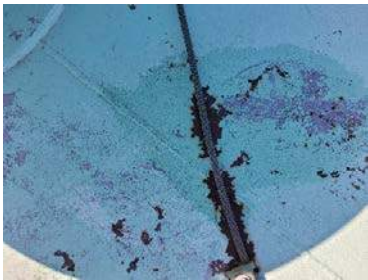
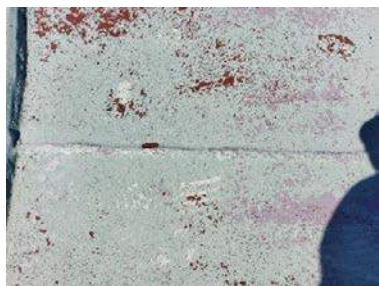
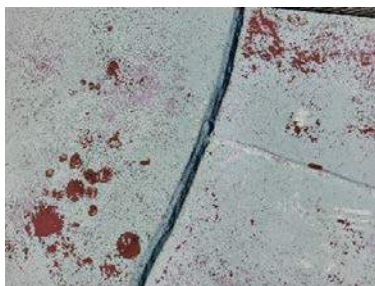
SOUTH ROOF STRUCTURAL	
Is there any sign of exposed steel?	Yes
Percent (%) of exposed steel in this quadrant	Less than 5%
Is there any sign of corrosion?	No
Is there any sign of pitting?	No
Are all penetrations sealed?	Yes
Ultra Sonic Thickness Measurements (In Inches)	.322 .310 .304 .316
Dry Film Thickness Measurements (In Mils)	4.29 5.39 6.2 5.31
Do all the welds in this section appear to be sound, free of fatigue /failure?	Yes
Does there appear to be any sign of leakage?	No

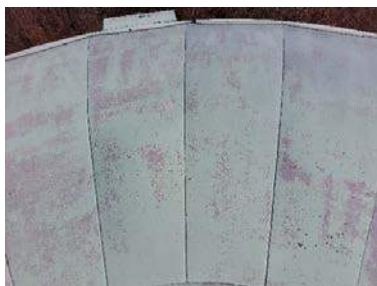
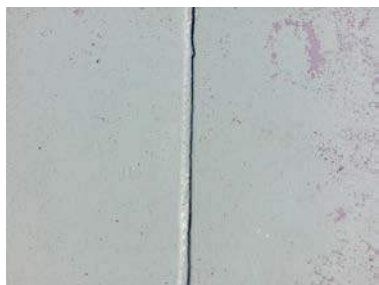
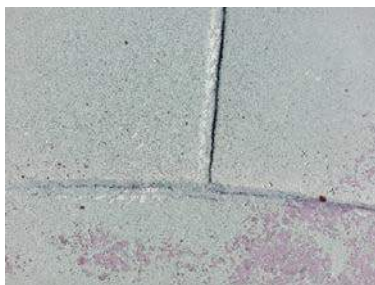
EAST ROOF STRUCTURAL	
Is there any sign of exposed steel?	No
Are all penetrations sealed?	Yes
Ultra Sonic Thickness Measurements (In Inches)	.302 .311 .338 .325
Dry Film Thickness Measurements (In Mils)	6.4 6.8 5.28 7.2
Do all the welds in this section appear to be sound, free of fatigue /failure?	Yes
Does there appear to be any sign of leakage?	No

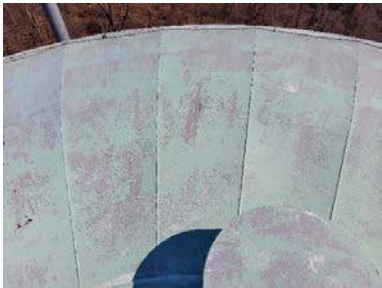
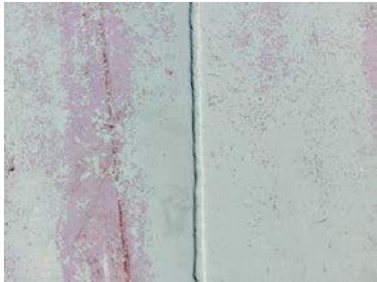
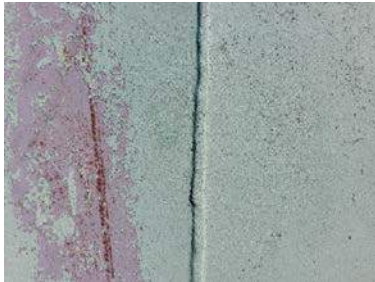
WEST ROOF STRUCTURAL	
Is there any sign of exposed steel?	No
Are all penetrations sealed?	Yes
Ultra Sonic Thickness Measurements (In Inches)	.339 .314 .311 .315
Dry Film Thickness Measurements (In Mils)	8.8 10.2 5.34 6.6
Do all the welds in this section appear to be sound, free of fatigue /failure?	Yes
Does there appear to be any sign of leakage?	No

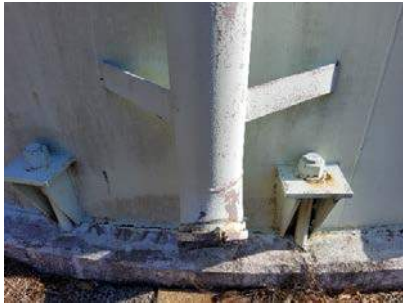
Overflow #1 Photo

OVERFLOW #1	
Location #1	East
Location #2	Wall
Where does this overflow terminate?	Into drain
How many inches above the ground does it terminate?	24
Does this overflow extend away from the structure?	No
Is this overflow free of obstructions?	Yes
Is there a screen present?	Yes
What size mesh is this screen?	18
Is this screen secure?	Yes
Does this screen have any deficiencies?	No
Is this overflow protected from wind driven rain?	No

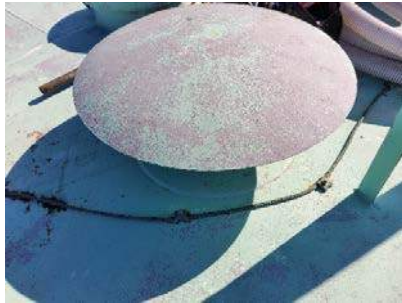
Vent 1 Photos

VENT #1	
Location #1	Center
Location #2	Roof
Is this vent coated?	Yes
What is the condition of the coating?	Decline/Thinning
Is this vent downturned?	No
Is there a solid cover down to the bottom of the screen?	No
Is there a screen present?	Yes
What size screen is present? (in inches)	4

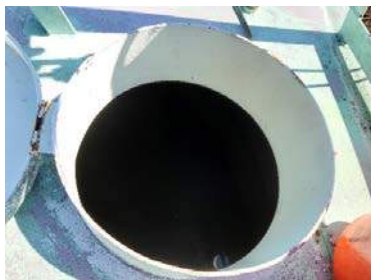
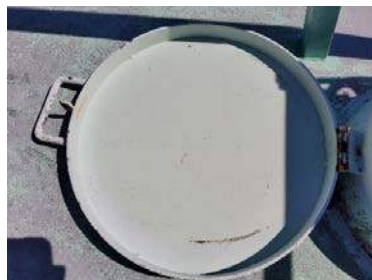
Hatch Photos

HATCH #1	
Location #1	North
Location #2	Roof
Shape	Circle
Diameter (in inches)	20
Is this hatch raised at least 4" above the roof?	Yes
Does this hatch have an overlapping water tight lid?	Yes
Does this lid have a gasket?	No
Was this hatch opened during inspection?	Yes
Did this hatch function properly?	Yes
Is this hatch secured with a lock?	No
Is this hatch coated?	Yes
Condition of coating on exterior	Decline/Thinning

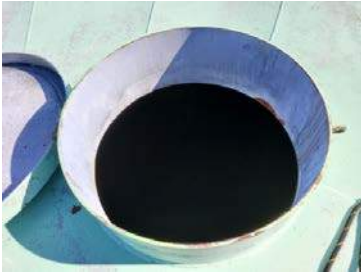
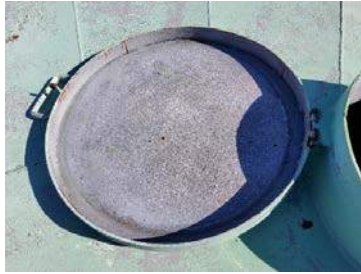
Hatch #2 Photos

HATCH #2	
Location #1	Center
Location #2	Roof
Shape	Circle
Diameter (in inches)	24
Is this hatch raised at least 4" above the roof?	Yes
Does this hatch have an overlapping water tight lid?	Yes
Does this lid have a gasket?	No
Was this hatch opened during inspection?	Yes
Did this hatch function properly?	Yes
Is this hatch secured with a lock?	No
Is this hatch coated?	Yes
Condition of coating on exterior	Decline/Thinning

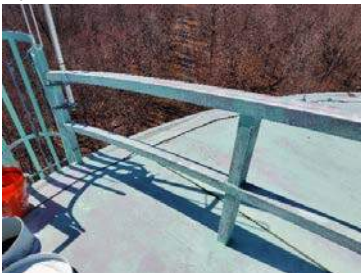
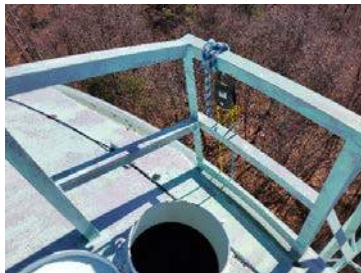
Safety Railing Photos

EXTERIOR SAFETY RAILINGS	
Does this structure have safety railings?	Yes
What is the material of the safety railings?	Steel
Is this safety railing coated?	Yes
Condition of coating	Decline/Thinning
Is this safety railing at least 42" to 43" in height?	Yes
What is the diameter of the tubing? (In Inches)	2
Does it span the circumference of the structure?	No
What is the approximate length of this railing? (In Inches)	400
Where is this safety railing located?	In front of north hatch and vent
Is this safety railing secure?	Yes
What is the overall condition of this safety railing?	Fair

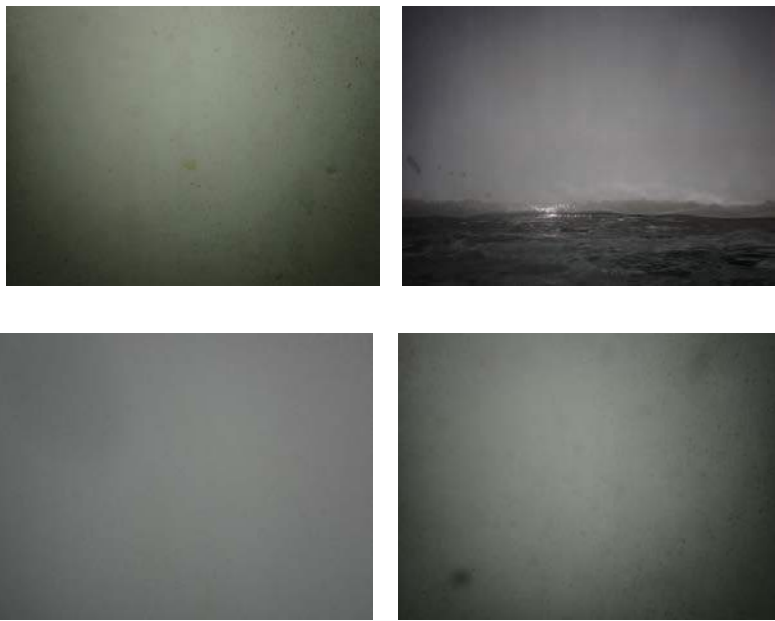
North Wall Aesthetics Photos

INTERIOR WALLS AESTHETICS	
INTERIOR AESTHETICS NORTH WALL	
Is there Biofilm/Staining in this quadrant?	Yes
Severity of biofilm	Mild
Is this quadrant coated?	Yes
Condition of Protective Coating	Decline/Thinning

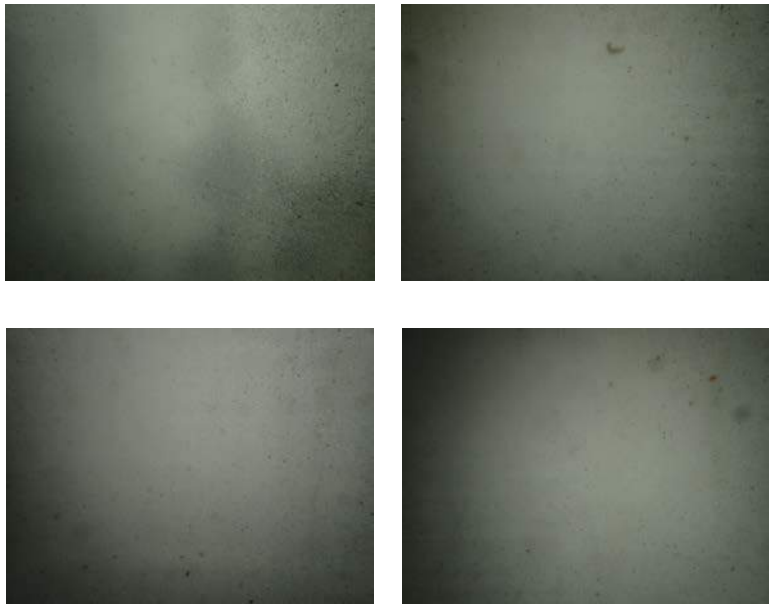
South Wall Aesthetics Photos

Is there Biofilm/Staining in this quadrant?	Yes
Severity of biofilm	Mild
Is this quadrant coated?	Yes
Condition of Protective Coating	Decline/Thinning

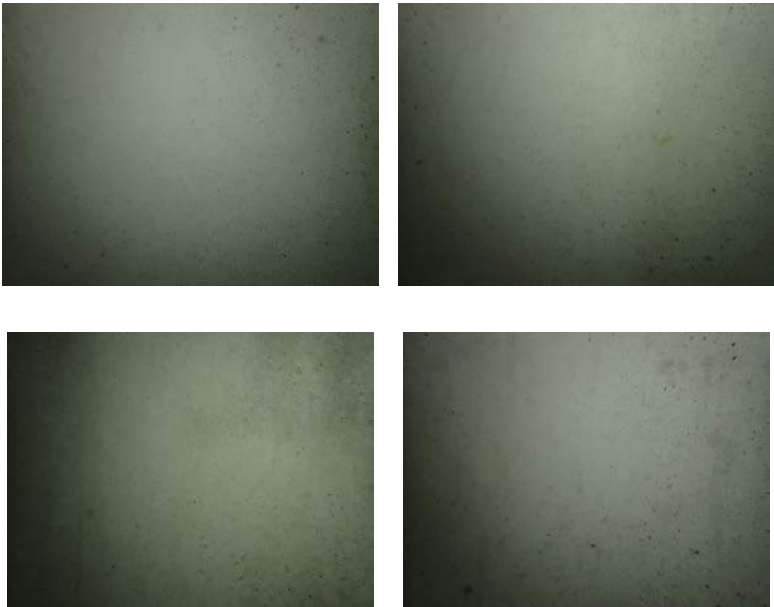
East Wall Aesthetics Photos

INTERIOR AESTHETICS EAST WALL	
Is there Biofilm/Staining in this quadrant?	Yes
Is this quadrant coated?	Yes
Condition of Protective Coating	Decline/Thinning

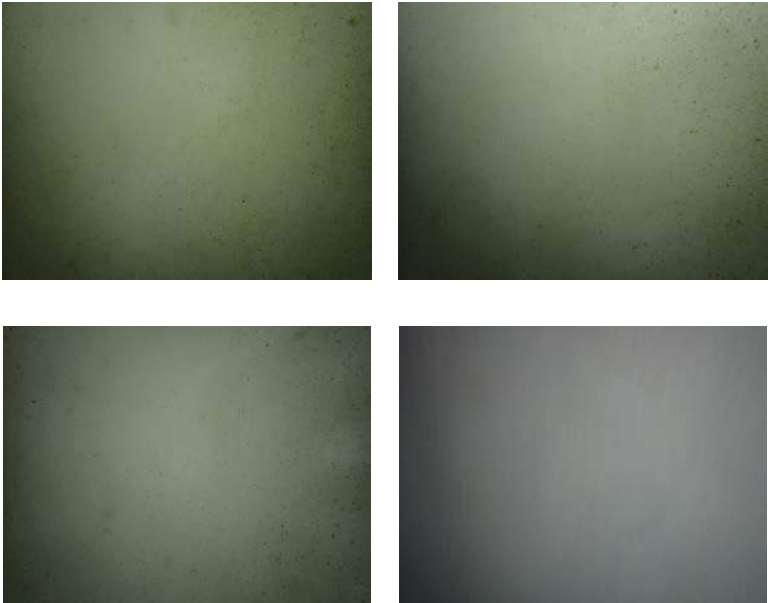
West Wall Aesthetics Photos

INTERIOR AESTHETICS WEST WALL	
Is there Biofilm/Staining in this quadrant?	Yes
Severity of biofilm	Mild
Is this quadrant coated?	Yes

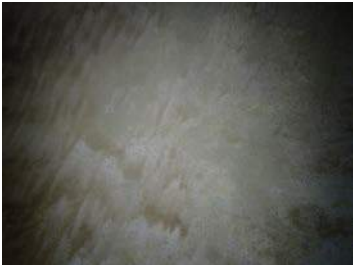
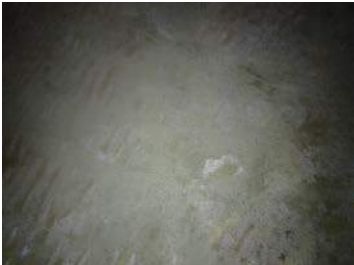
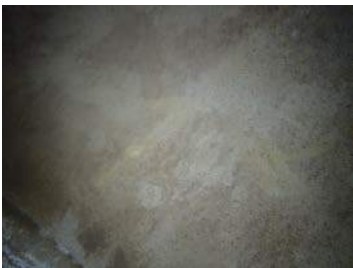
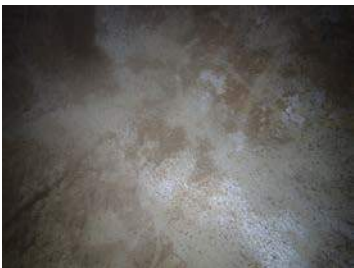
South Floor Aesthetics Photos

Is there Biofilm/Staining in this quadrant?	Yes
Severity of biofilm/staining?	Moderate
Is this quadrant coated?	No

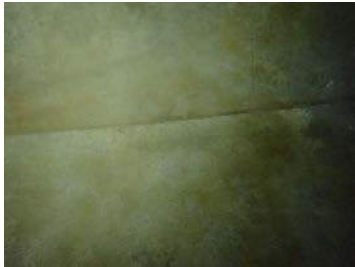
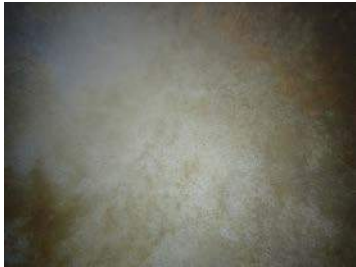
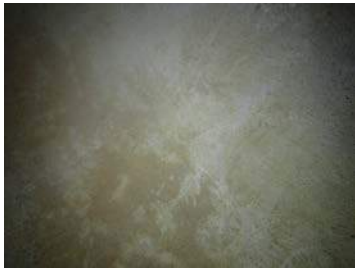
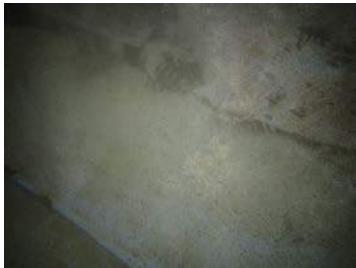
East Floor Aesthetic Photos

Is there Biofilm/Staining in this quadrant?	Yes
Severity of biofilm/staining?	Moderate
Is this quadrant coated?	No

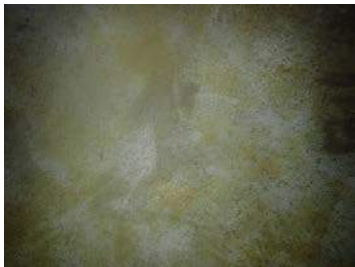
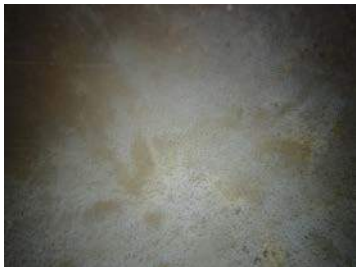
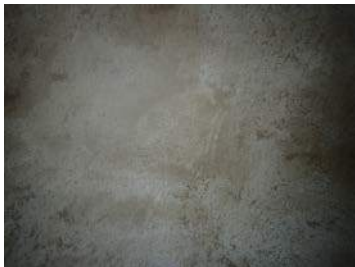
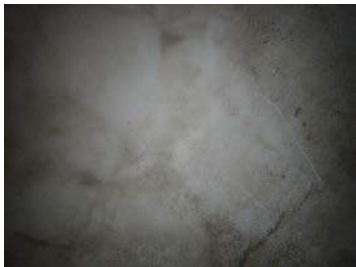
West Floor Aesthetic Photos

Is there Biofilm/Staining in this quadrant?	Yes
Severity of biofilm/staining?	Moderate
Is this quadrant coated?	No

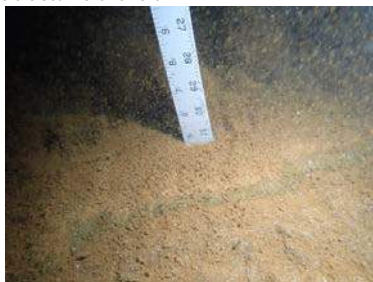
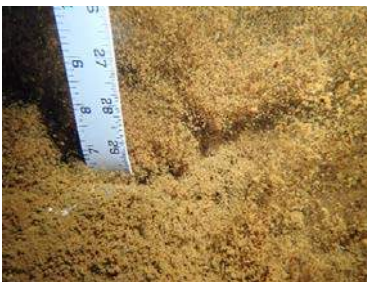
**Before Sediment Removal**

How much sediment was found on the bottom of this structure? (In Inches)	4.5 - 6.5
Sediment appears to be:	Brown sediment with white top layer
Was all sediment removed?	Yes

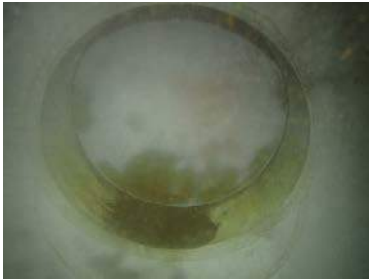
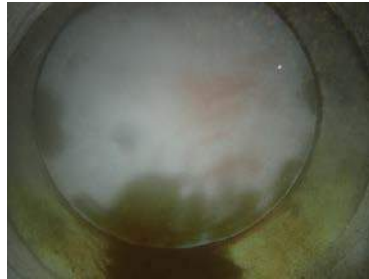
#### Interior Manway Photos

Location #1	East
Location #2	Wall
Shape	Circle
Diameter	24
Height above floor (in inches)	24
Is this manway secure?	Yes
Is there any sign of leakage?	No
Is this manway coated?	Yes
Condition of coating	Decline/Thinning
Is there any signs of metal exposure?	No
Is there any sign of corrosion?	No
Is there any sign of fatigue/pitting?	No
What is the condition of the gasket?	Good
Is there an access ladder for this manway?	No

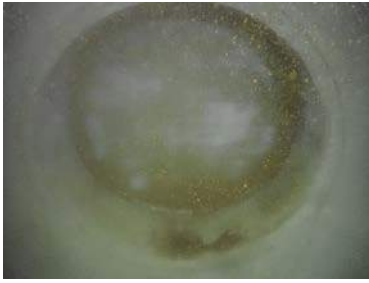
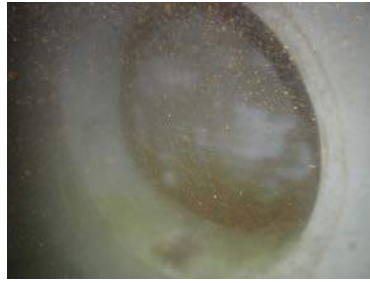
#### Interior Manway #2 Photos

Location #1	West
Location #2	Wall
Shape	Circle
Diameter	24
Height above floor (in inches)	24
Is this manway secure?	Yes
Is there any sign of leakage?	No
Is this manway coated?	Yes
Condition of coating	Decline/Thinning
Is there any signs of metal exposure?	No
Is there any sign of corrosion?	No
Is there any sign of fatigue/pitting?	No
What is the condition of the gasket?	Good
Is there an access ladder for this manway?	No

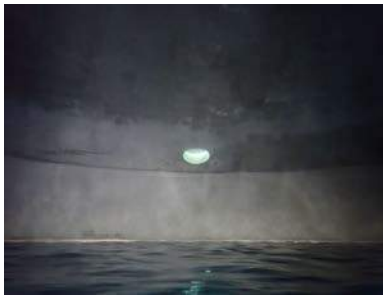
Overflow #1 Photo

OVERFLOW #1	
Location #1	East
Location #2	Wall
Is this overflow free of obstructions?	Yes
What is this overflow penetrating?	Wall
Where does this overflow terminate?	Wall
Is this overflow coated?	Yes
Condition of coating	Decline/Thinning
Is this overflow supported?	No

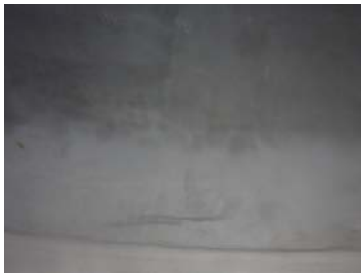
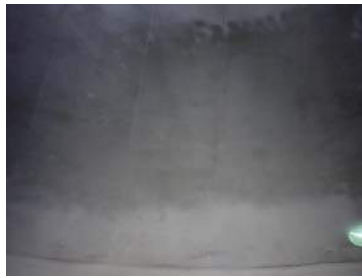
North Overhead Aesthetics Photos

NORTH OVERHEAD AESTHETICS QUADRANT	
Aesthetic Deficiencies	Soiling
Is this quadrant coated?	Yes
Condition of Protective Coating	Decline/Thinning
Is the hatch visible in this quadrant?	Yes
Aesthetic Deficiencies	Good

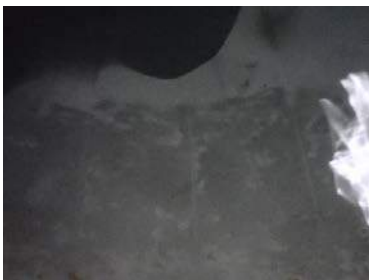
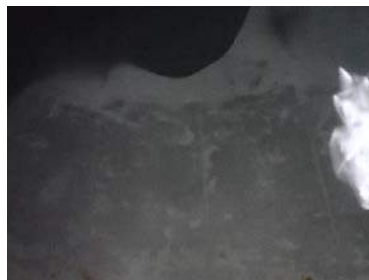
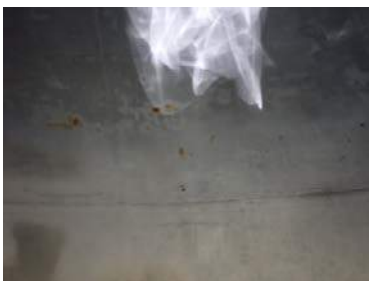
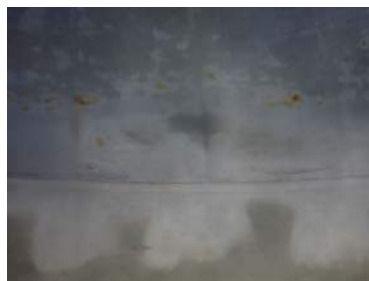
#### South Overhead Aesthetics Photos

SOUTH OVERHEAD AESTHETICS QUADRANT	
Aesthetic Deficiencies	Soiling
Is this quadrant coated?	Yes
Condition of Protective Coating	Decline/Thinning
Is the hatch visible in this quadrant?	No

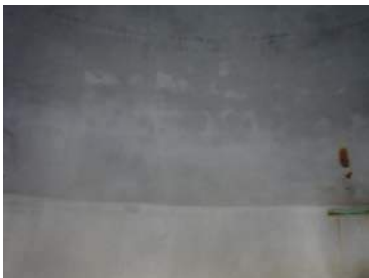
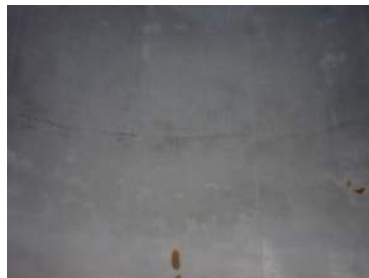
#### East Overhead Aesthetics - Photos

EAST OVERHEAD AESTHETICS QUADRANT	
Aesthetic Deficiencies	Soiling
Is this quadrant coated?	Yes
Condition of Protective Coating	Decline/Thinning
Is the hatch visible in this quadrant?	No

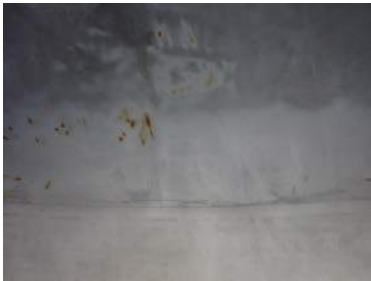
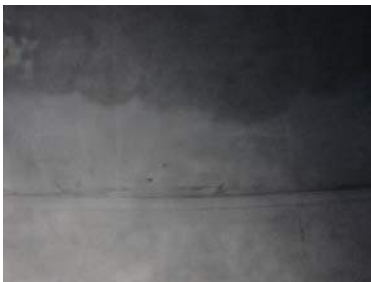
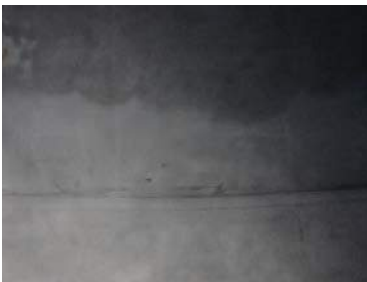
**West Overhead Aesthetics Photos**

WEST OVERHEAD AESTHETICS QUADRANT	
Aesthetic Deficiencies	Soiling
Is this quadrant coated?	Yes
Condition of Protective Coating	Decline/Thinning
Is the hatch visible in this quadrant?	Yes
Aesthetic Deficiencies	Good

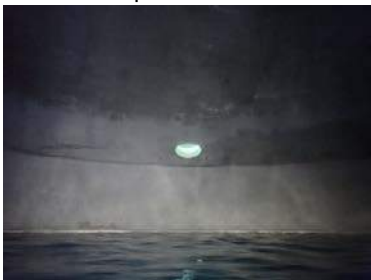
**Overall Photo of this quadrant**

NORTH OVERHEAD STRUCTURAL QUADRANT	
Is there any sign of exposed steel?	No
